# Monitoring of changes of external climate influence on inner microclimate of sacral building

Lukas Balik<sup>1,\*</sup>, Lucie Kudrnacova<sup>1</sup> and Klara Nedvedova<sup>1</sup>

<sup>1</sup> Klokner Institute Czech Technical University  
Solinova 7, 160 00, Prague (Czech Republic)  
lukas.balik@cvut.cz

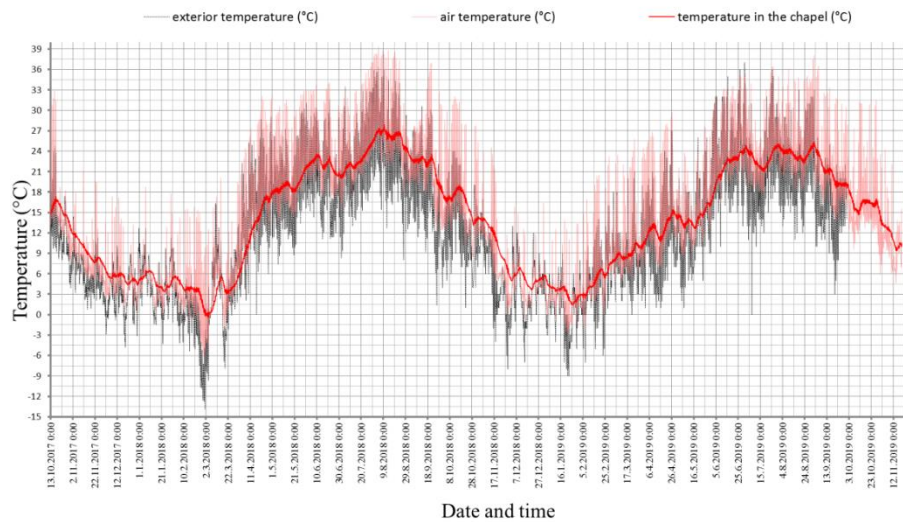
**Fig. 2** Course of temperatures in the chapel (space and immediate proximity of the window panel) and exterior in the period October 2017 to November 2019

- 1) the characteristics of the indoor microclimate in the immediate vicinity of the window panel and stone sill (hereinafter referred to as detail) are significantly different from the microclimate in the open space of the chapel (Fig. 2 and 5);

- 2) temperatures close to detail oscillated between  $-14.3$  to  $37$  ° C with average value of  $12.5$  ° C in the two-year cycle and in the open space between  $-0.4$  to  $13.9$  ° C with average value of  $13.9$  ° C;

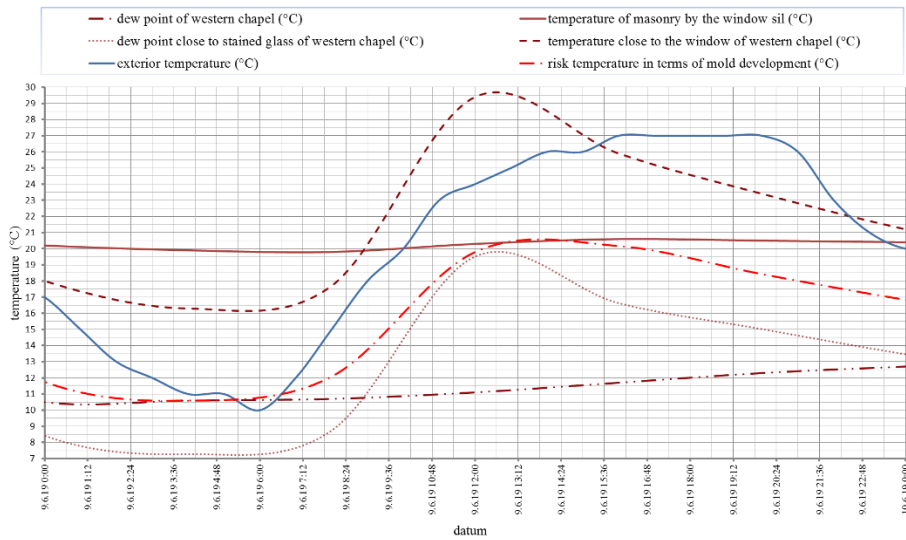
**Fig. 3** Graphs of selected temperatures on the surface of the stone window sill of the stained glass window as of 9.6. 2018

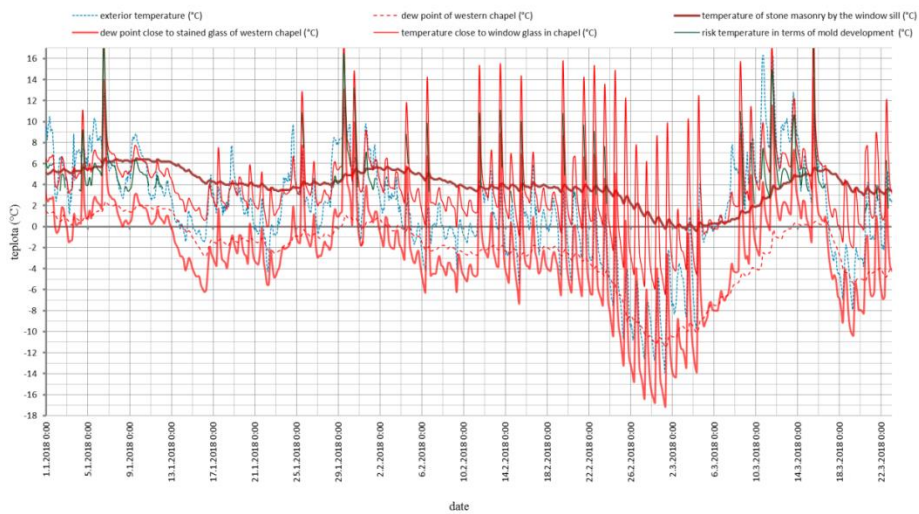
**Fig. 4** Waveforms of selected temperatures and dew point near the contact between the glass window and the window sill

- 3) no significant condensation process has been recorded in the side chapel area (on the inner wall surface) (Fig. 4);
- 4) a process of periodically occurring water vapor condensation has been recorded on the perimeter walls near the detail (Fig. 4);

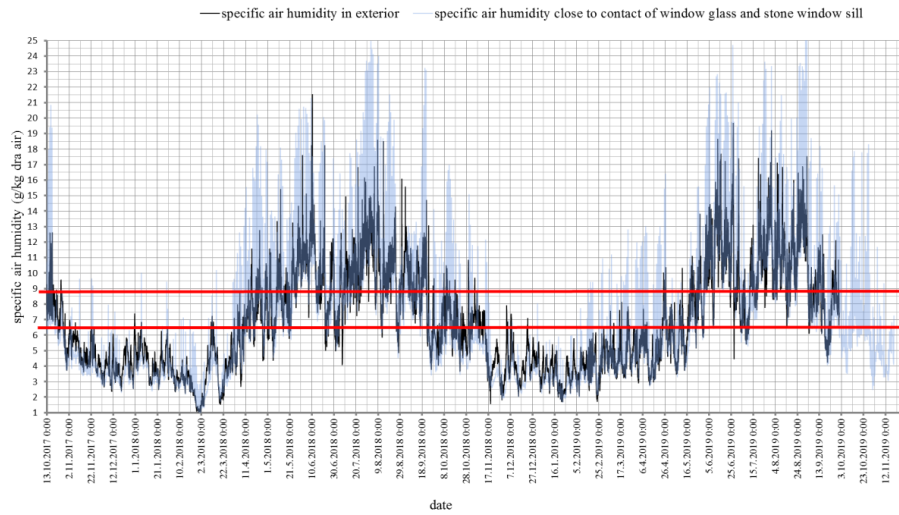
**Fig. 5** Specific humidity of selected areas from October 2017 to November 2019

- 7) in the area of detail, there is a sharp periodic change of the specific air humidity (Fig. 5, 6, 7) compared to the chapel space, where its changes are significantly attenuated;

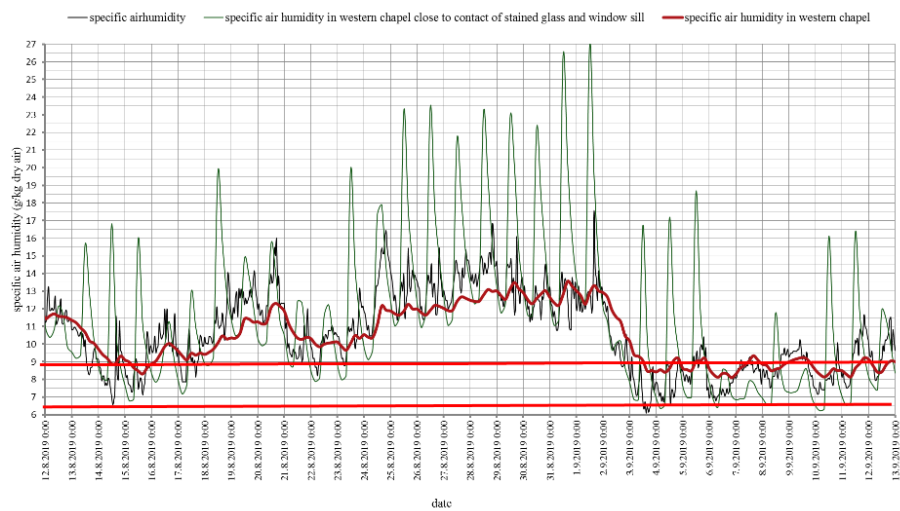
**Fig. 6** Specific humidity of the western chapel in the immediate vicinity of the contact between the window panel (stained glass) and the stone sill in the period from 12 August to 13 September 2019

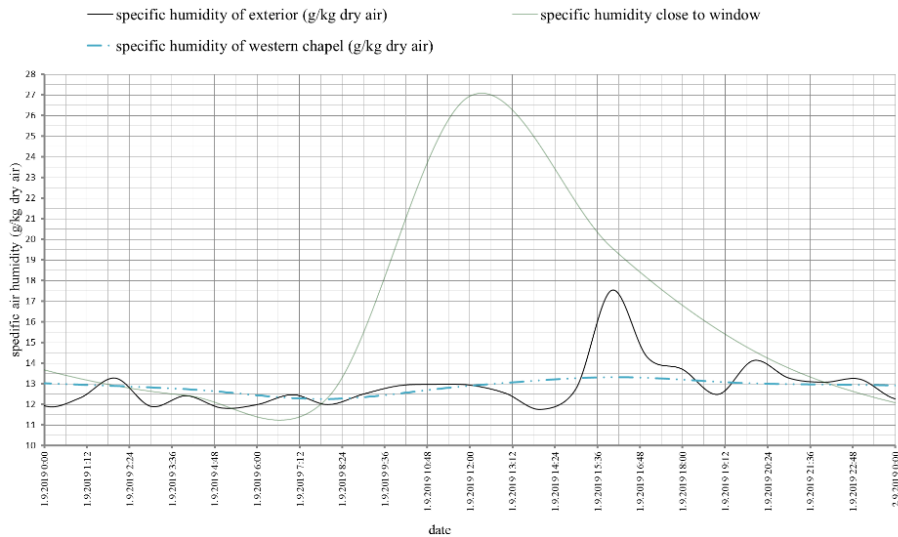
**Fig. 7** Specific humidity of the western chapel in the immediate vicinity of the window panel (stained glass) and the stone sill in the period from 12 August to 13 September 2019

8) variations in specific air humidity in the detail area reached up to 16 g / kg dry air at a time interval of 5 hours (Fig. 7);
