# Verification of Software for Planning Maintenance and Restoration of Historic Buildings in a Case Study

# 4 General repair and construction modifications of the historical building of the Dobrovice Parish

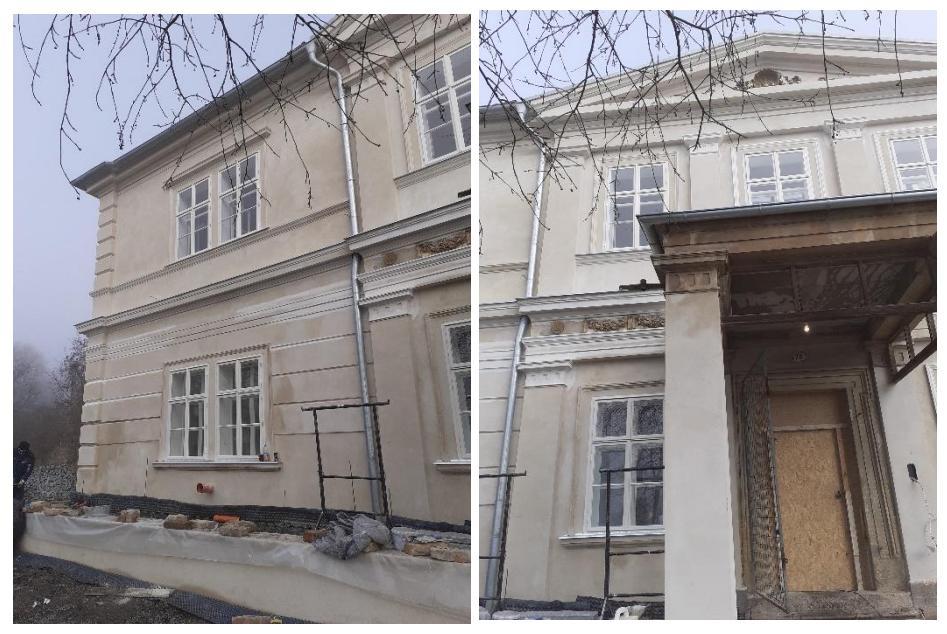
Fig. 2. View of the Dobrovice Parish after the general repair and construction modifications.

Considering that this is an immovable cultural monument, the architectural and material solution was planned to be preserved without changes. The facades are preserved without changes, only the simple division of the northern facade is added. The facade is designed in shades of sand color. The hipped roof is covered with a new burnt roof, natural beavers for a scale covering, or grooves.
